Care of Churches and Ecclesiastical Jurisdiction Measure 1991 – Quinquennial Inspection  
**ST STEPHEN'S CHURCH, FYLINGDALES**

Diocese: York  
Archdeaconry: Cleveland  
Church Code: 643 614

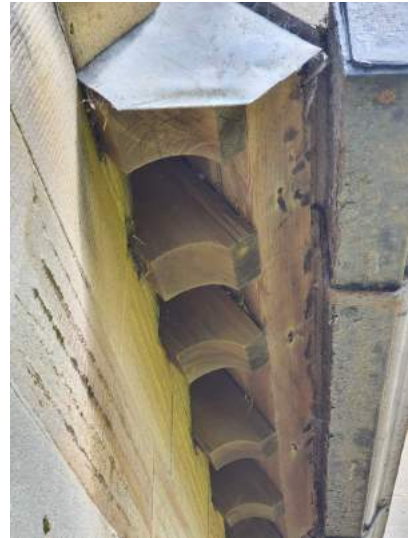
b) Exposed rafter ends in fair condition.

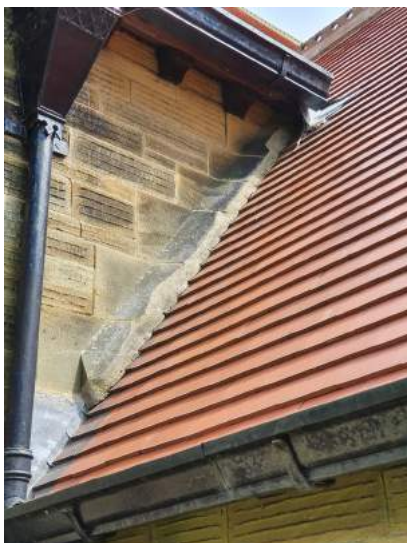
a) Mortar haunching thought to cover lead flashing below.

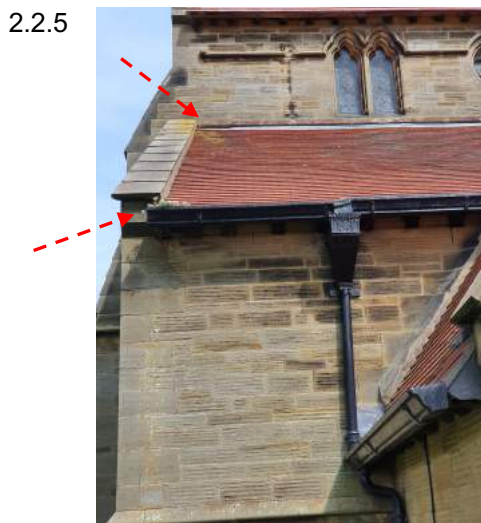
a) Distorted lead and vegetation in gutter

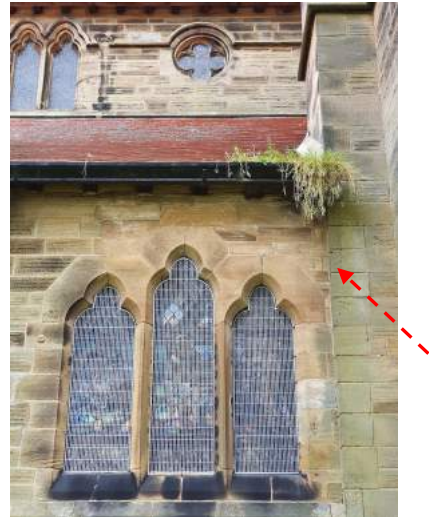
b) Clear gutter to prevent further spillage and staining.

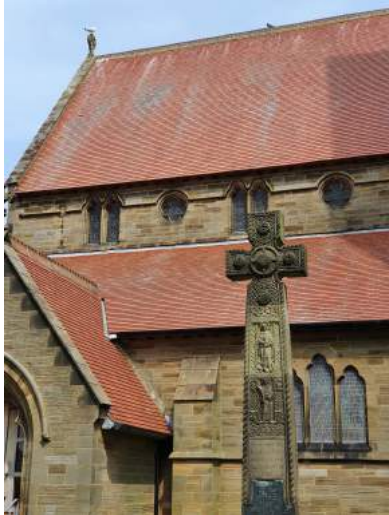
a) Tiles to repair on the Nave south slope

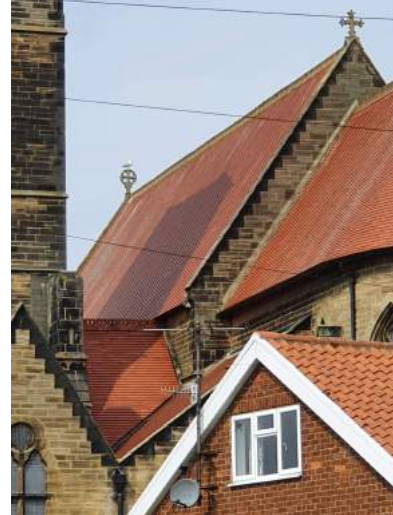
b) South slope viewed from the SE.

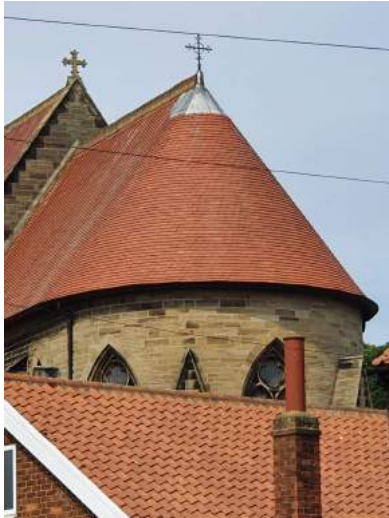
*a) Apsidal roof at the east end over the sanctuary*

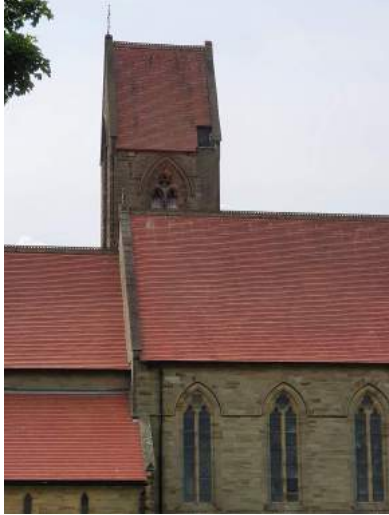
*a) Access door is visible at the eaves of the north slope of the tower roof*

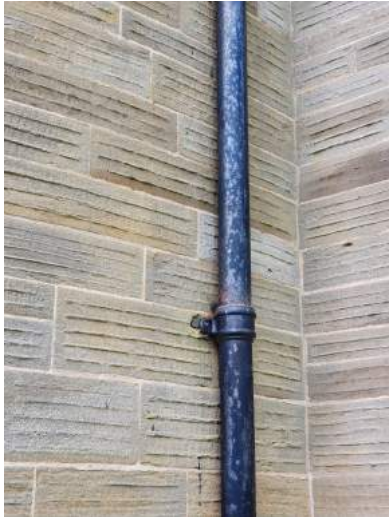
a) Ironwork to be brushed down and redecorated

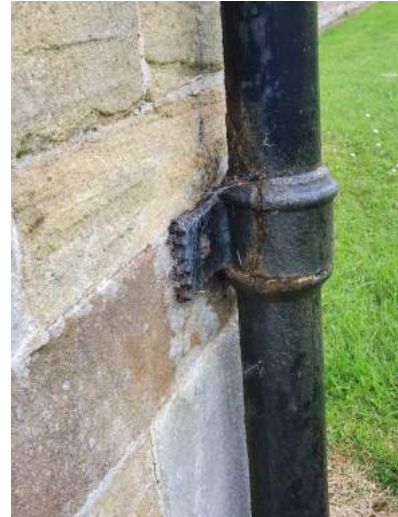
b) Fractured cast iron

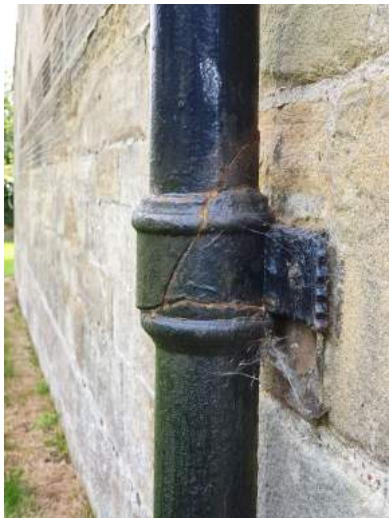
a) Fractured bracket/ pipework

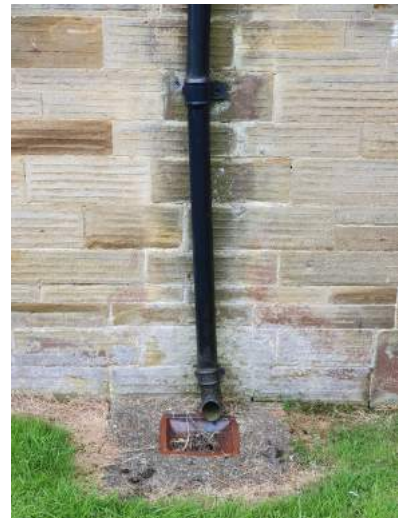
b) Downpipe is misaligned and the adjacent masonry is stained. Refurbish all downpipes and gutters checking for leaks.

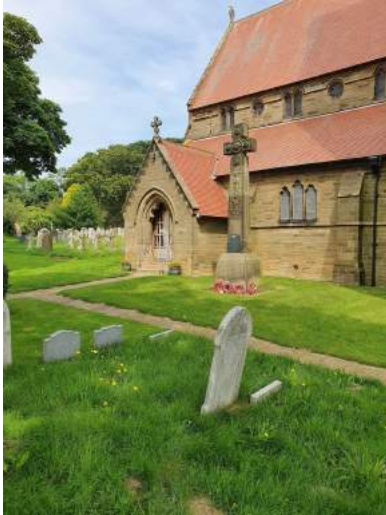
*a) South clerestory*

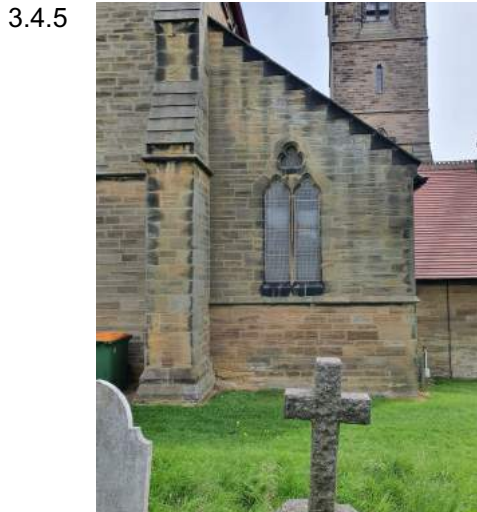
a) West aisle elevation.

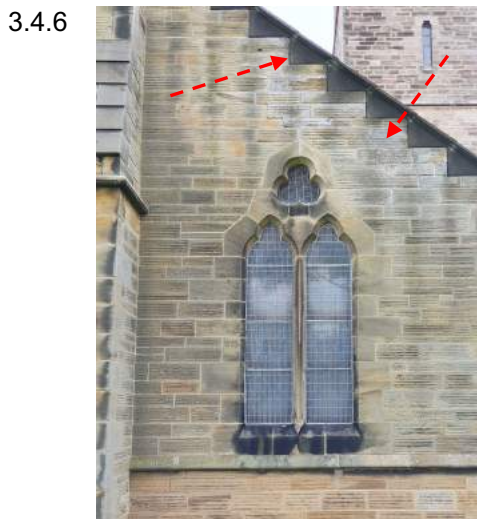
a) Open jointed coping blocks and salt staining.

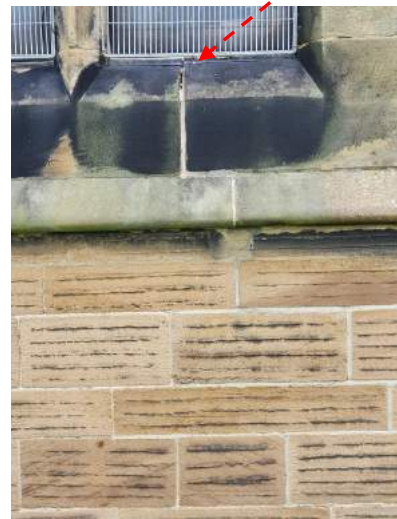
b) Open joint at cill needs to be repointed.

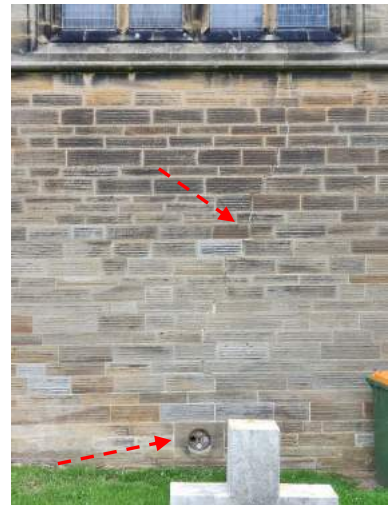
b) Longstanding crack below cill.

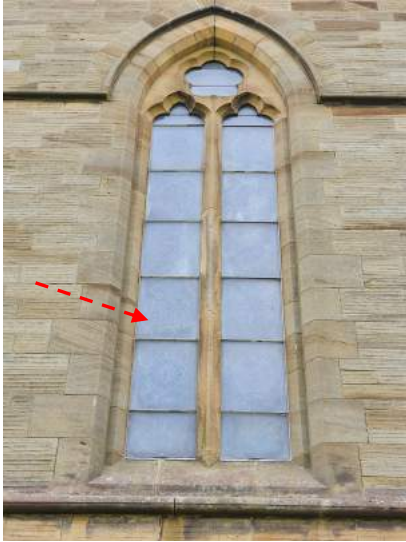
*a) Exterior secondary glazing is cracked*

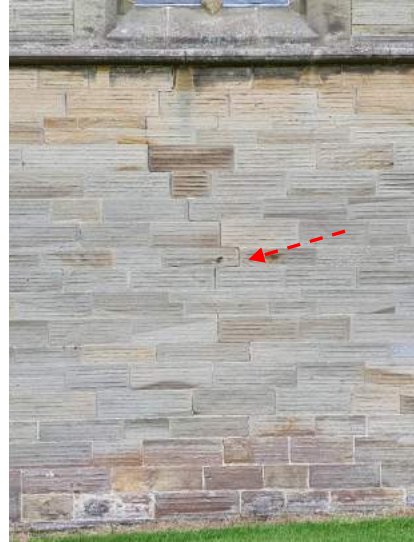
*b) Crack has been repointed and the old replacement mortar has fallen out. Repointing required.*

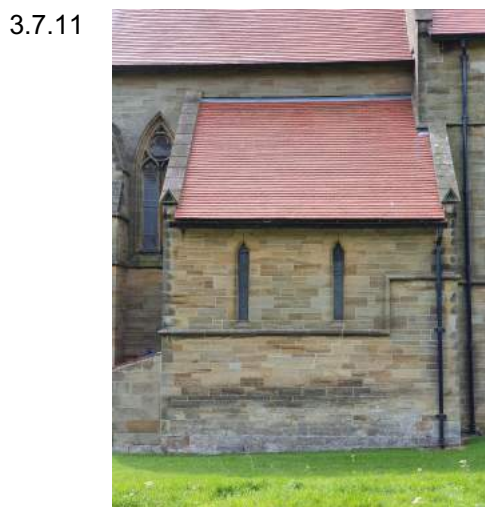
- 3.7.10 On the west elevation of the Choir Vestry there is a ventilation grille in cast iron which is heavily corroded and falling to pieces. The ventilation route is being used to discharge drainage from the sink. Repair is needed. **2**

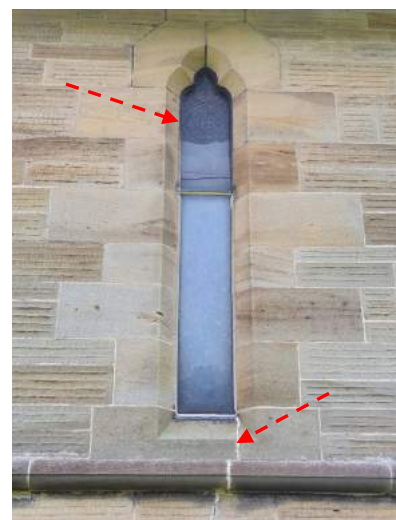
b) Repointing and broken secondary glazing

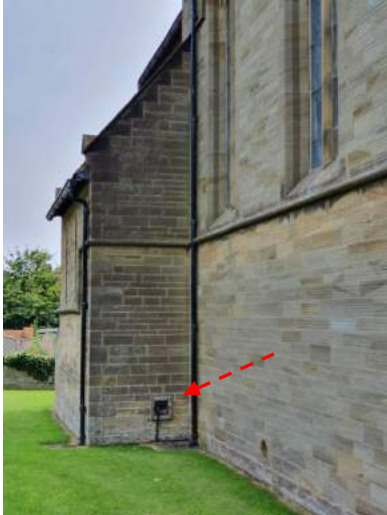
*a) Repair ventilation grille*

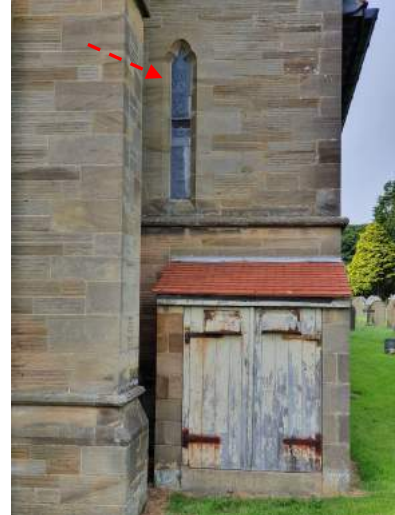
*b) Weathered doors and corroded hinges. Broken secondary glazing.*

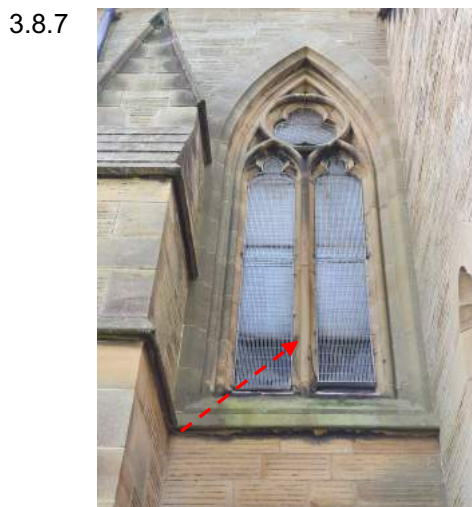
a) Masonry repair needed

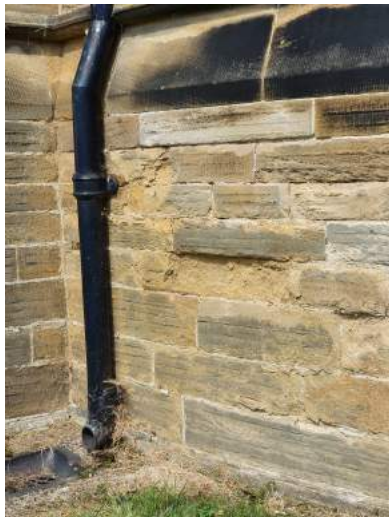
*a) Repointing and mortar repair required,*

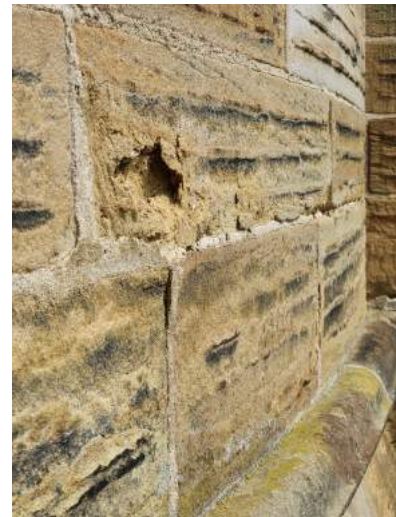
*b) The use of inappropriate mortar for previous repairs is probably contributing to the masonry erosion starting to develop.*

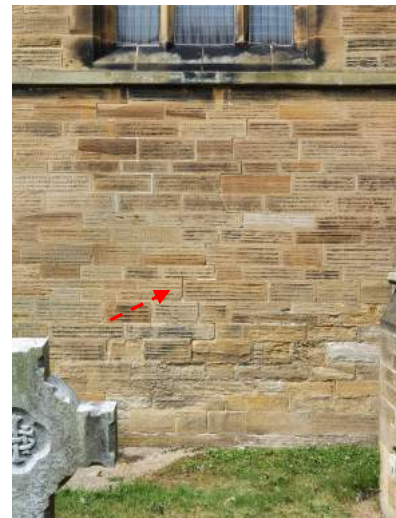
b) Crack below Chapel window

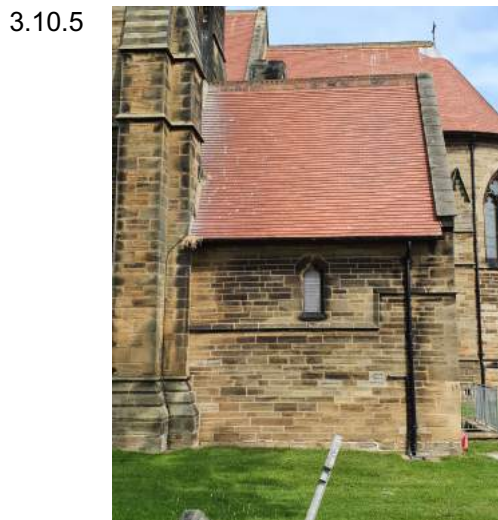
a) Vestry north window

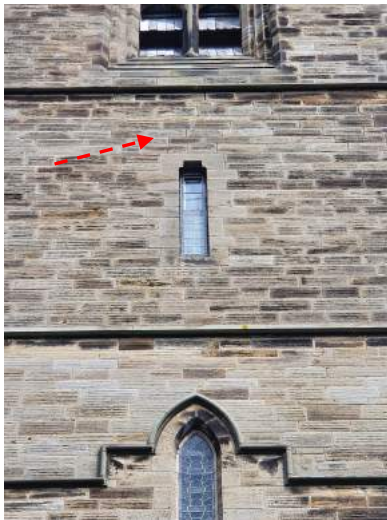
a) Crack to be repointed

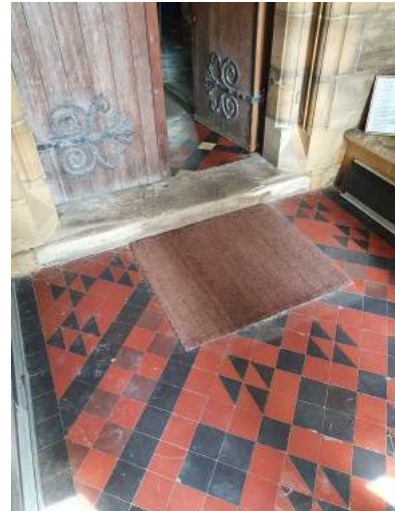
b) Open perpendicular joints and surface erosion caused by rising damp.

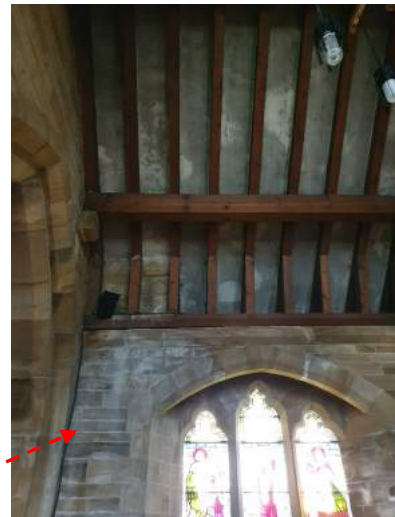
b) Salt staining and defective ceiling panels.

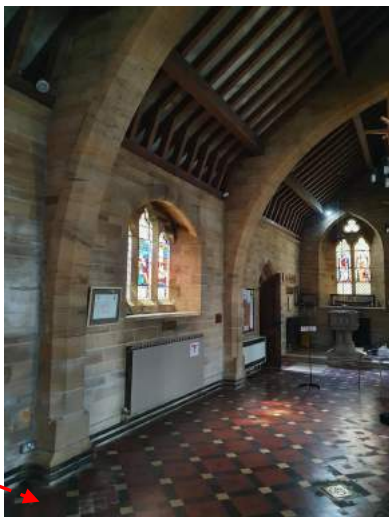
a) Mild salt deposit on floor tiles

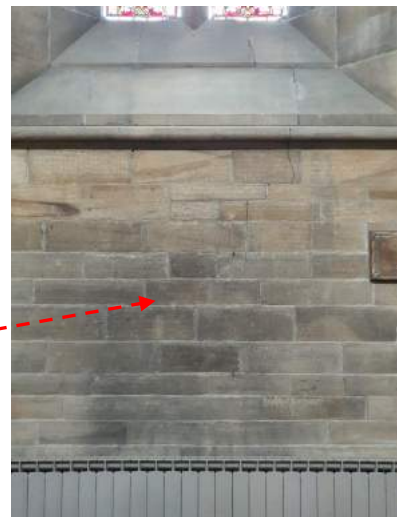
b) Crack below the Nave north window cill

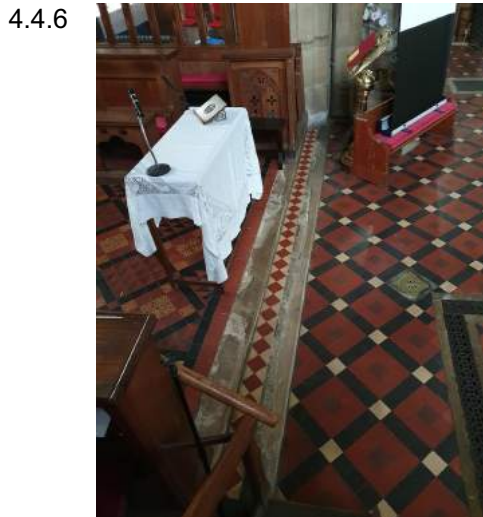
a) Chancel steps shows moisture damage

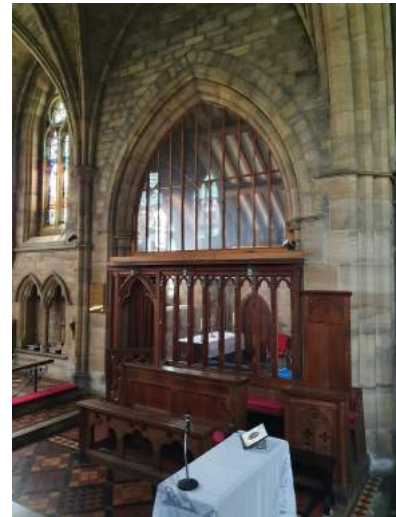
b) Choir stalls and screen separating the Chancel and Chapel

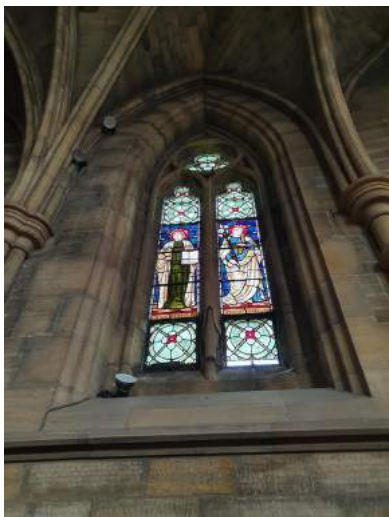
a) North apse window central mullion has been repaired but shows signs of continuing erosion that reflects the location of external masonry defects

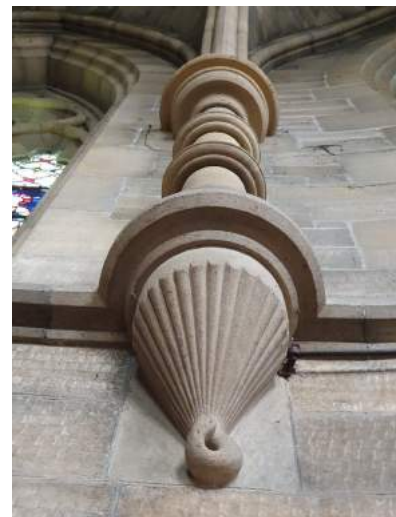
b) Fine carving to pilaster corbels

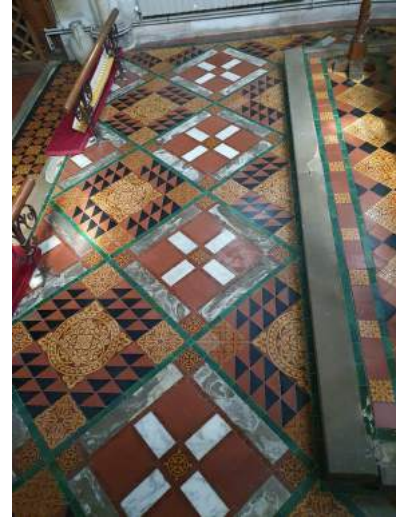
*b) Moisture damage is concentrated in the sandstone inserts. The ceramic tiles appear more resilient to rising damp.*

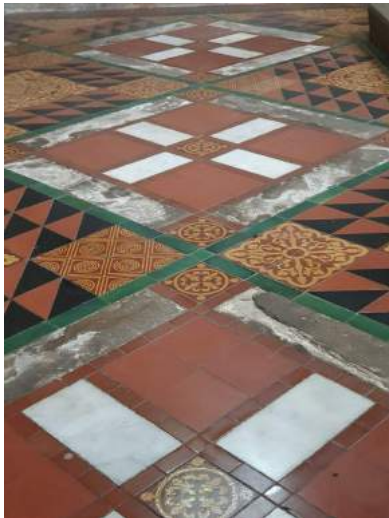
*a) Sanctuary floor detail*

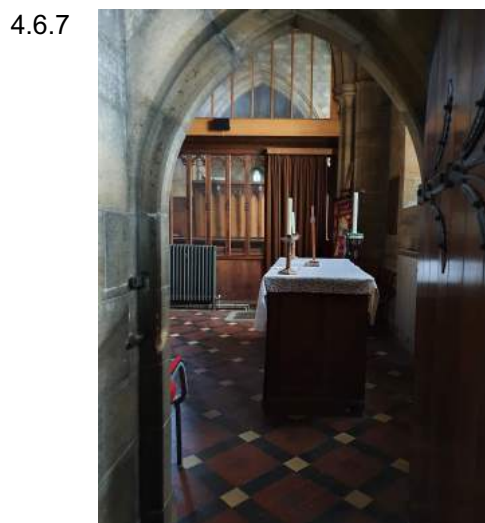
a) View through the doorway from the Vestry

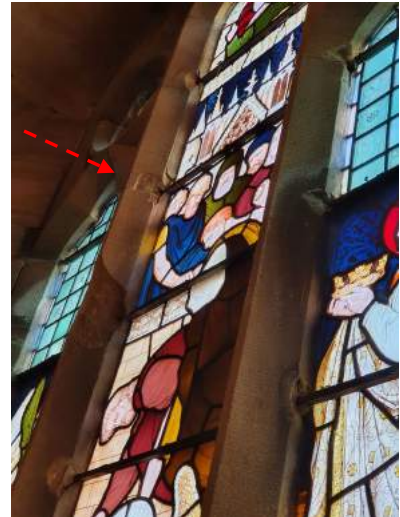
b) Masonry damage most likely due to corrosion in the saddle bars.

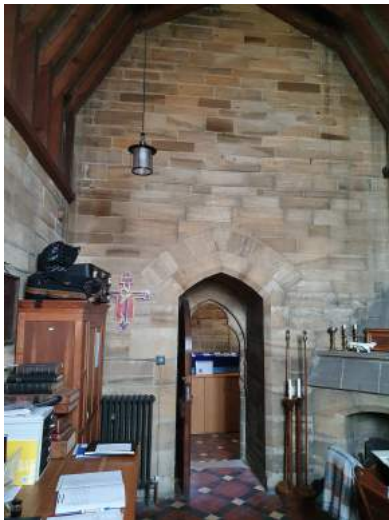
a) Entrance from tower base. Historic staining/ funnel marks at high level. Fireplace in right of photo.

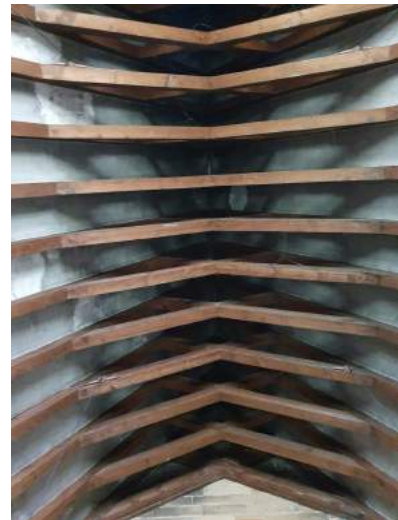
b) Scissor truss roof

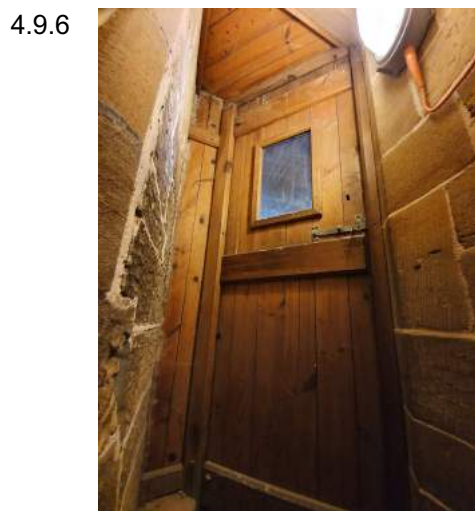
a) Ring chamber door at the top of the stair

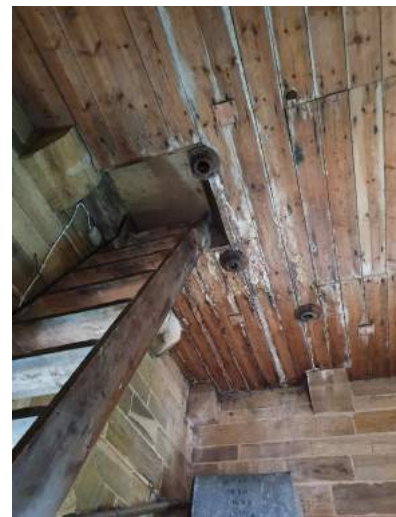
b) Hatch to belfry is awkward to open. Note stained ceiling boards.

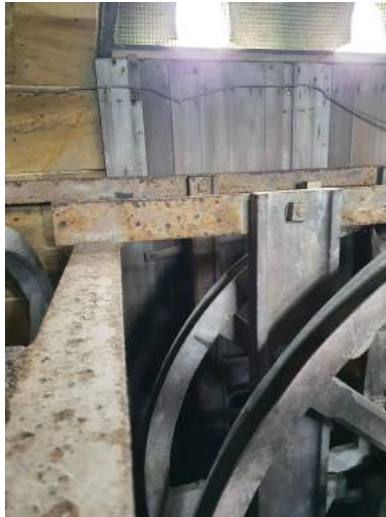
a) Bell frame corrosion

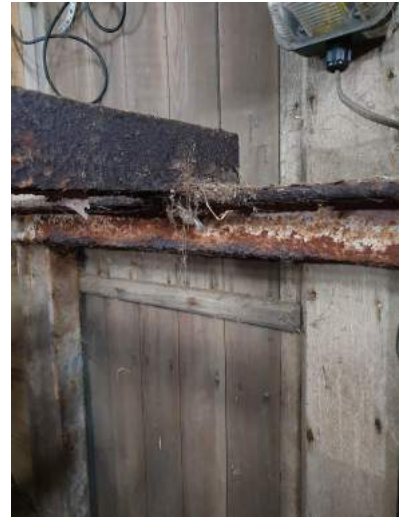
b) Bell frame corrosion

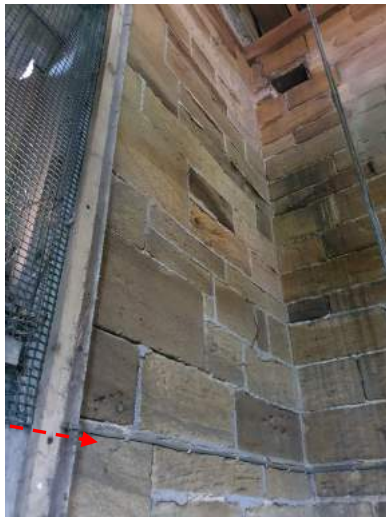
a) Note the light grey cement based mortar

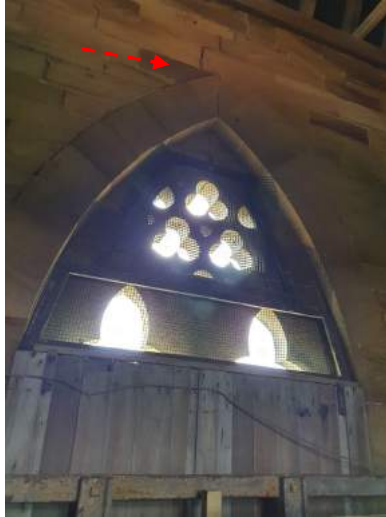
*a) Typical Belfry opening. Stepped crack in mortar joint at the head of belfry opening*

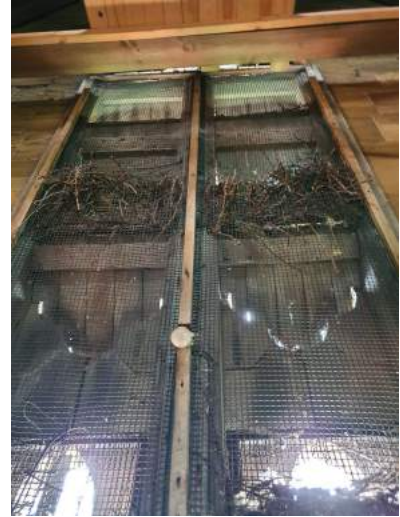
*b) Nest established between louvres and mesh.*

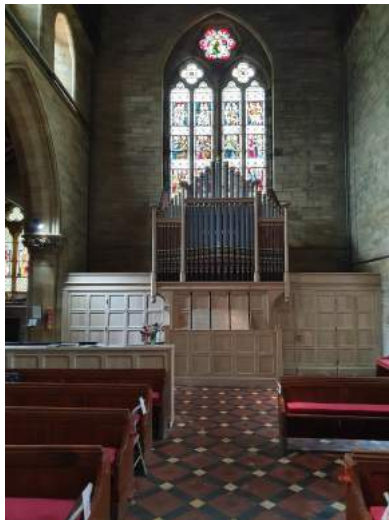
*a) Organ with WC and kitchen facilities conceal behind oak panelling at either side.*

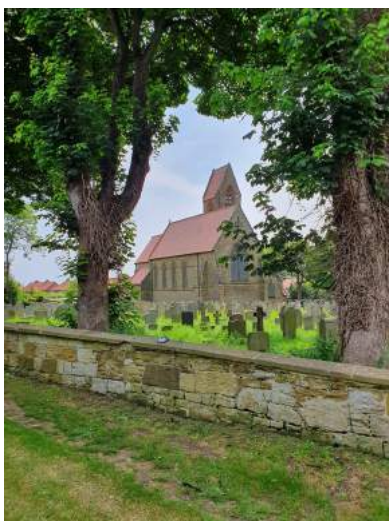
a) North boundary in fair condition

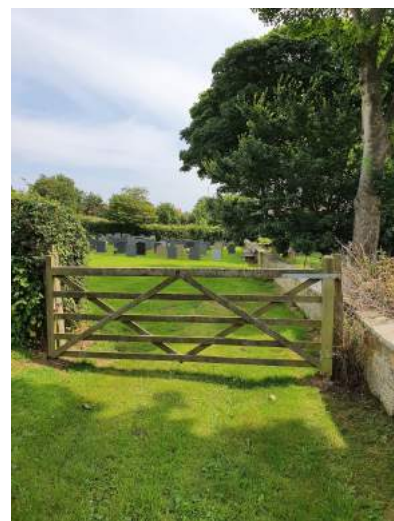
b) North churchyard/ extended burial ground

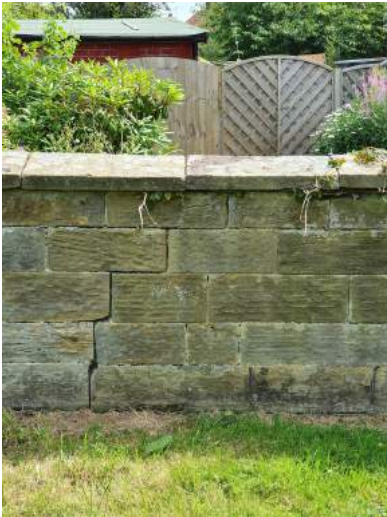
*a) Open joints form stepped crack in east boundary wall that ought to be repointed*

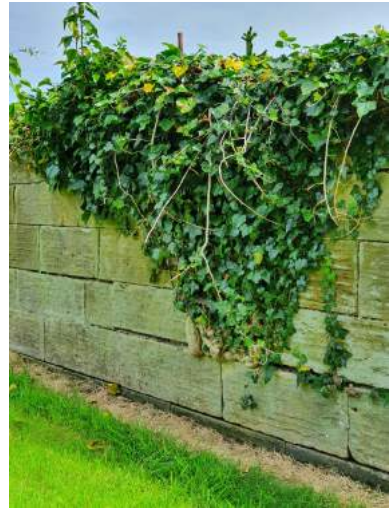
*b) East boundary – ivy has grown through the wall and is damaging its construction. The vegetation needs to be cut back, controlled and the wall repaired.*
