Care of Churches and Ecclesiastical Jurisdiction Measure 1991 – Quinquennial Inspection
ST STEPHEN'S CHURCH, FYLINGDALES

Diocese: York
Archdeaconry: Cleveland
Church Code: 643 614

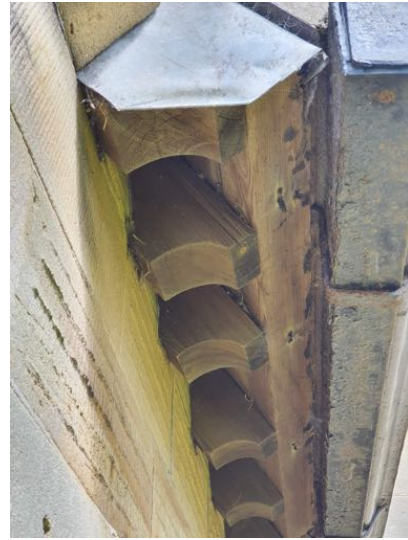
b) Exposed rafter ends in fair condition.

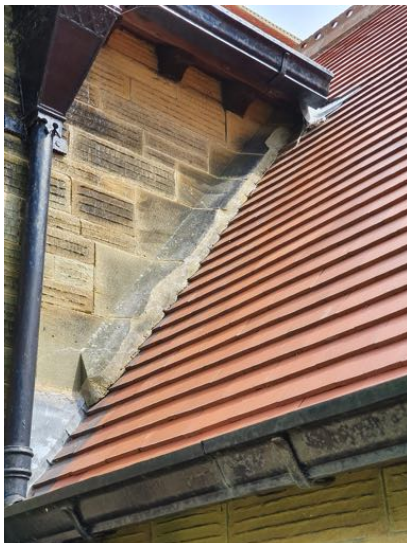
a) Mortar haunching thought to cover lead flashing below.

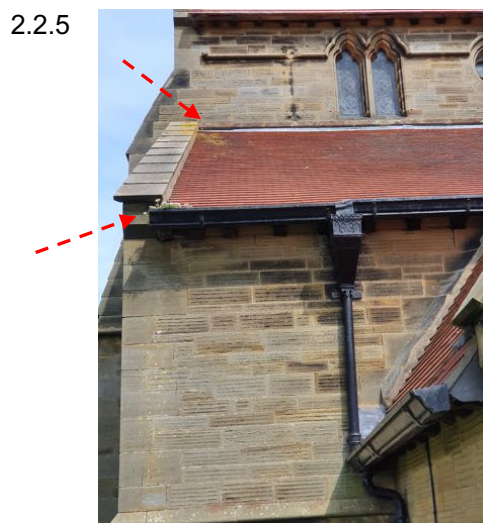
a) Distorted lead and vegetation in gutter

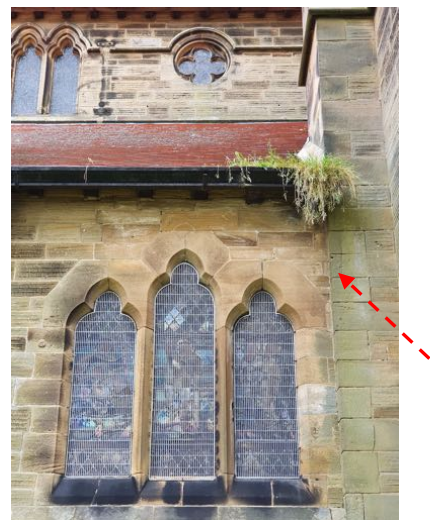
b) Clear gutter to prevent further spillage and staining.

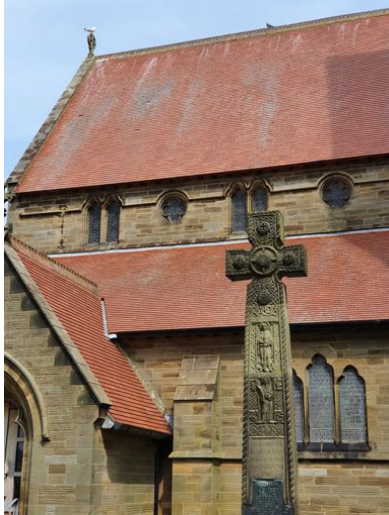
a) Tiles to repair on the Nave south slope

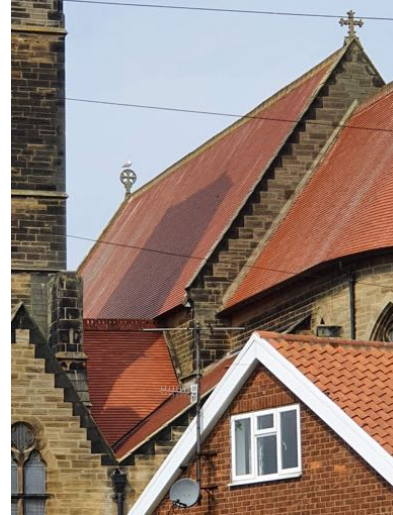
b) South slope viewed from the SE.

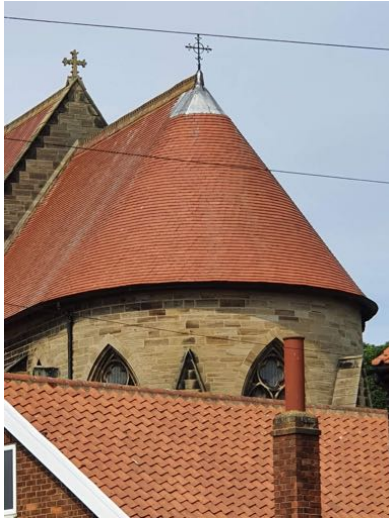
a) Apsidal roof at the east end over the sanctuary

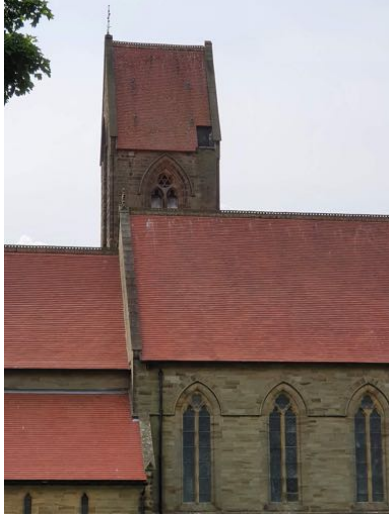
a) Access door is visible at the eaves of the north slope of the tower roof

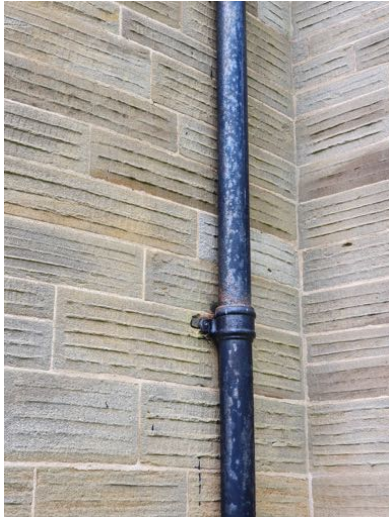
a) Ironwork to be brushed down and redecorated

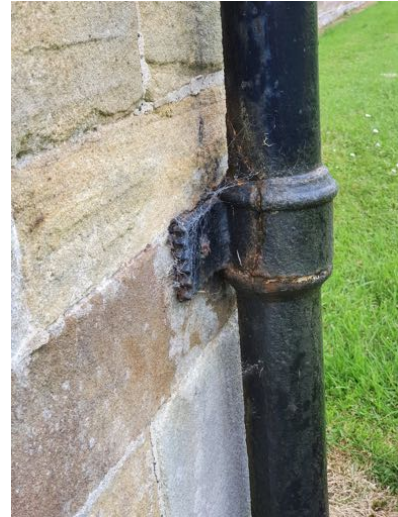
b) Fractured cast iron

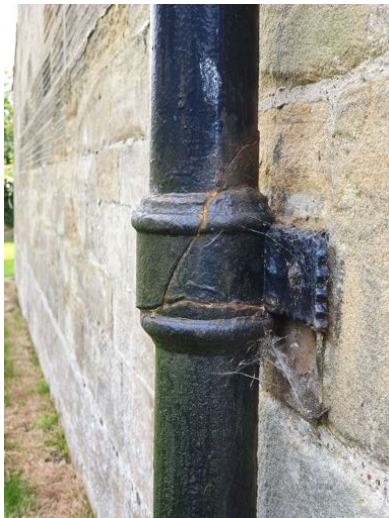
a) Fractured bracket/ pipework

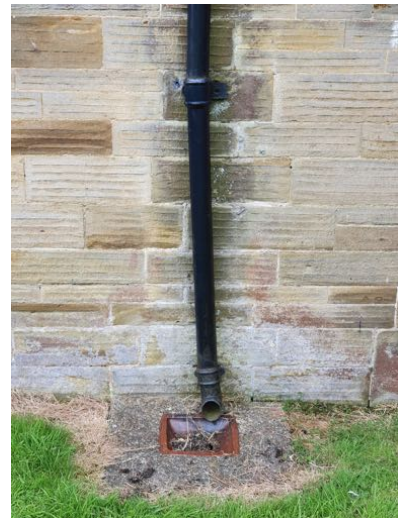
b) Downpipe is misaligned and the adjacent masonry is stained. Refurbish all downpipes and gutters checking for leaks.

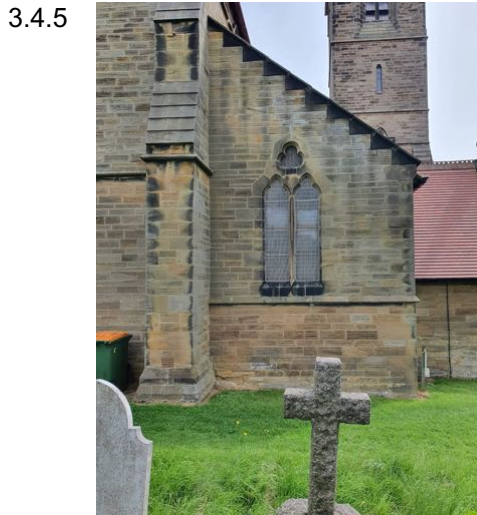
a) West aisle elevation.

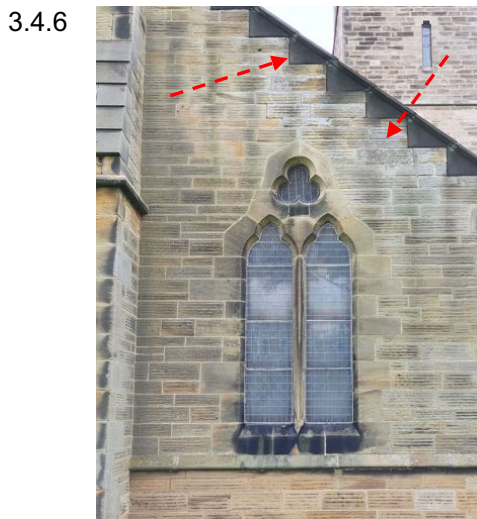
a) Open jointed coping blocks and salt staining.

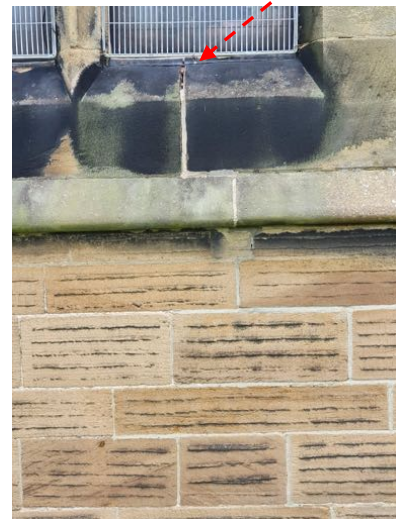
b) Open joint at cill needs to be repointed.

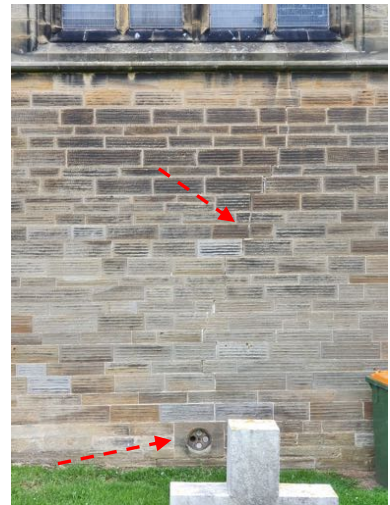
b) Longstanding crack below cill.

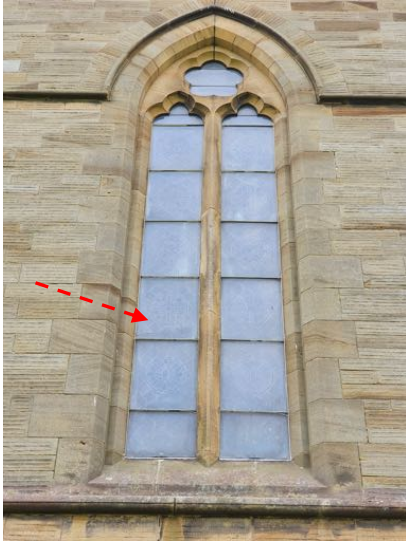
a) Exterior secondary glazing is cracked

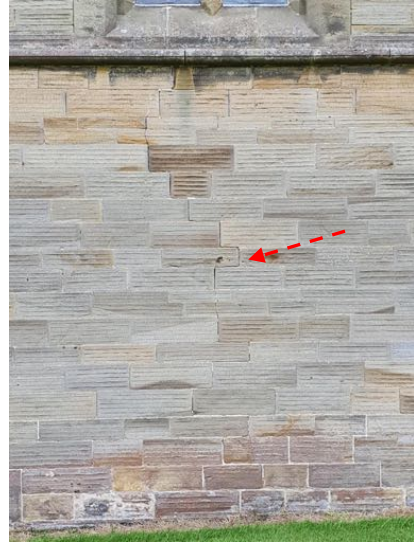
b) Crack has been repointed and the old replacement mortar has fallen out. Repointing required.

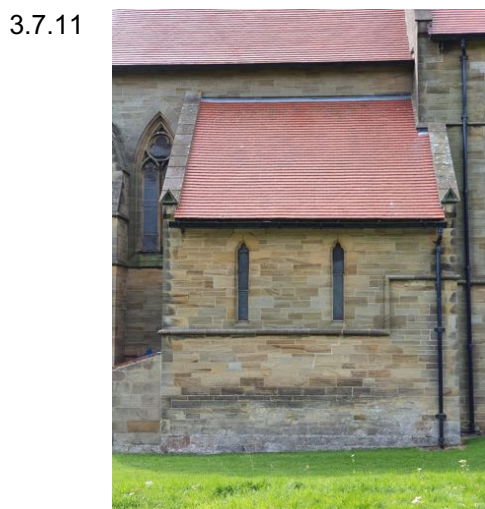
- 3.7.10 On the west elevation of the Choir Vestry there is a ventilation grille in cast iron which is heavily corroded and falling to pieces. The ventilation route is being used to discharge drainage from the sink. Repair is needed. **2**

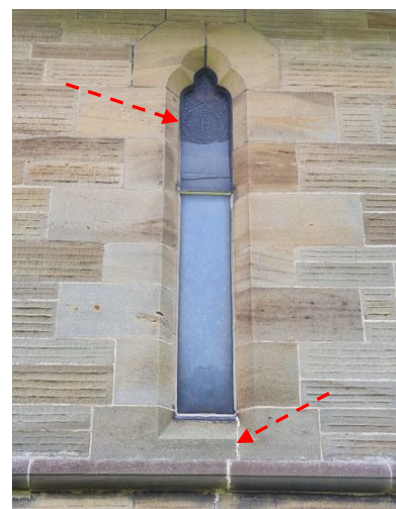
b) Repointing and broken secondary glazing

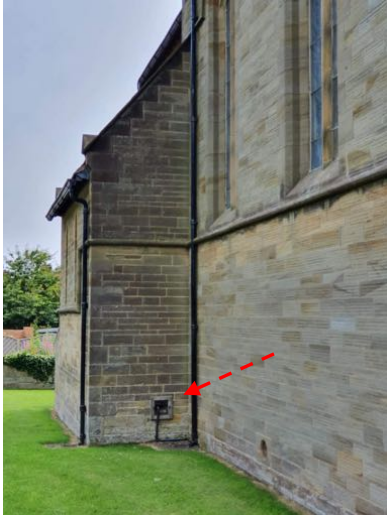
a) Repair ventilation grille

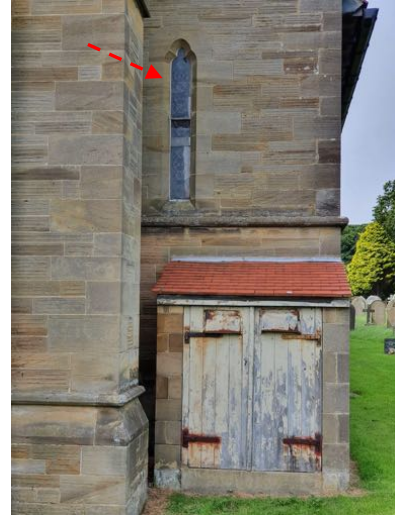
b) Weathered doors and corroded hinges. Broken secondary glazing.

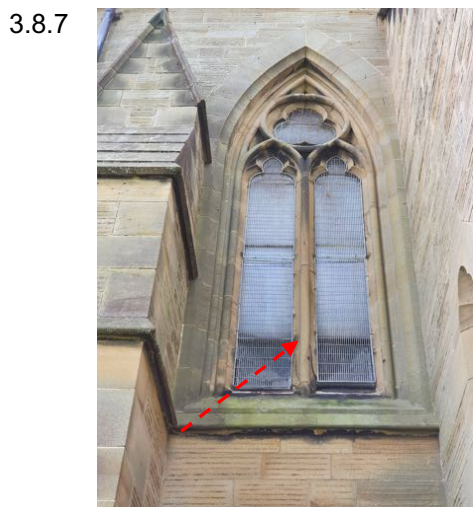
a) Masonry repair needed

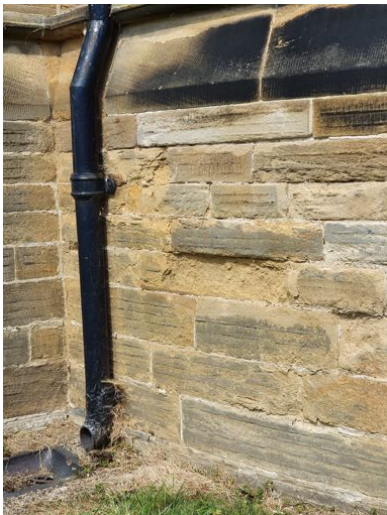
a) Repointing and mortar repair required,

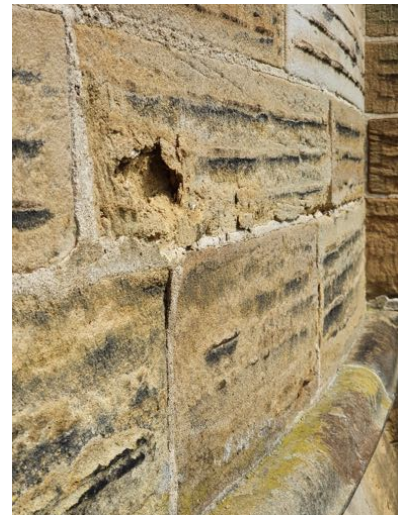
b) The use of inappropriate mortar for previous repairs is probably contributing to the masonry erosion starting to develop.

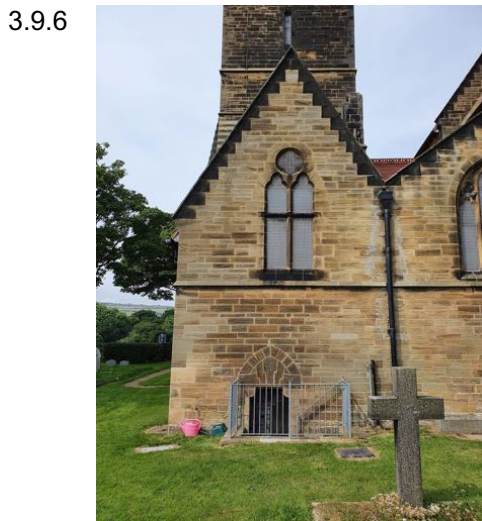
- 3.9.5 Stepped access to the basement is secured with a galvanised metal handrail. The copings that secure the hand rail have been repaired since the last QI report in 2016.

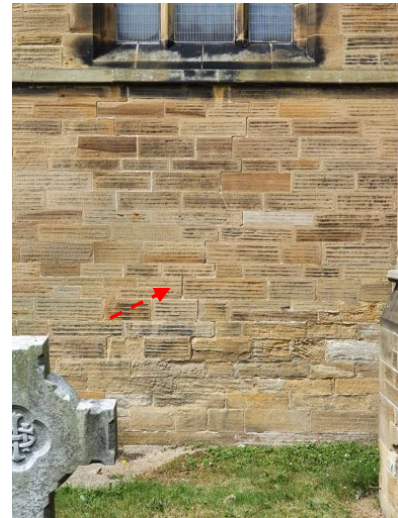
b) Crack below Chapel window

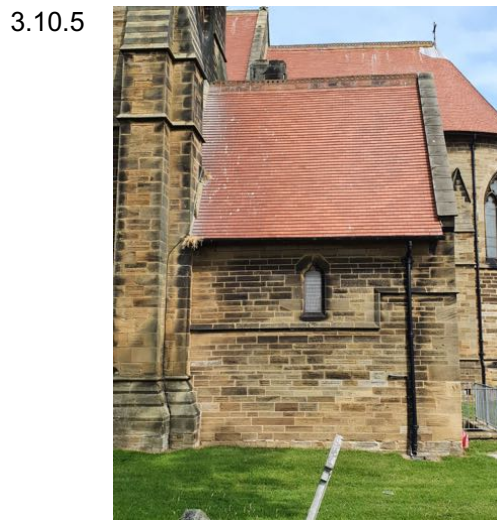
a) Vestry north window

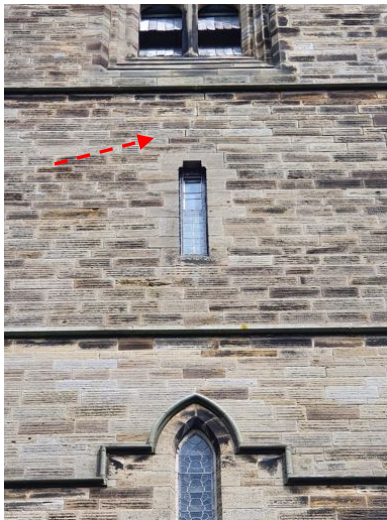
a) Crack to be repointed

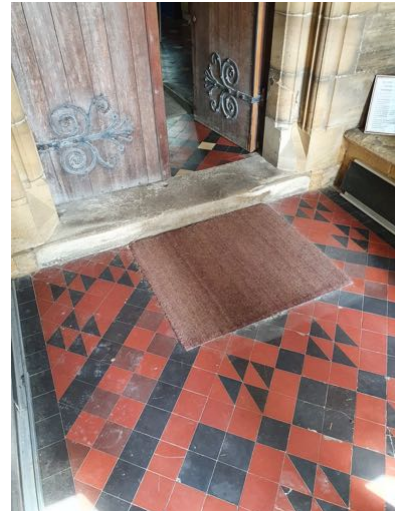
b) Open perpendicular joints and surface erosion caused by rising damp.

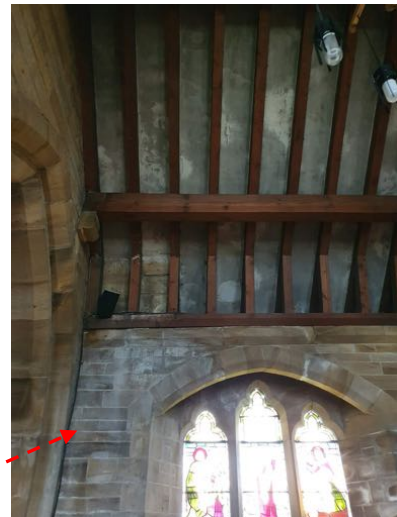
b) Salt staining and defective ceiling panels.

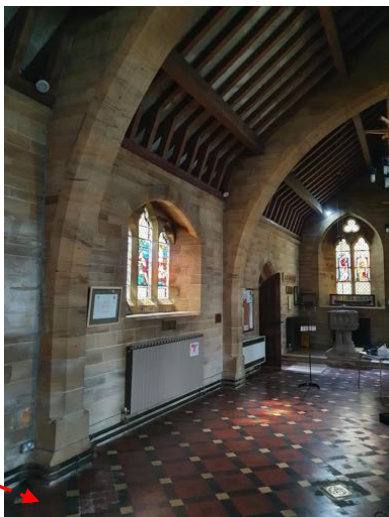
a) Mild salt deposit on floor tiles

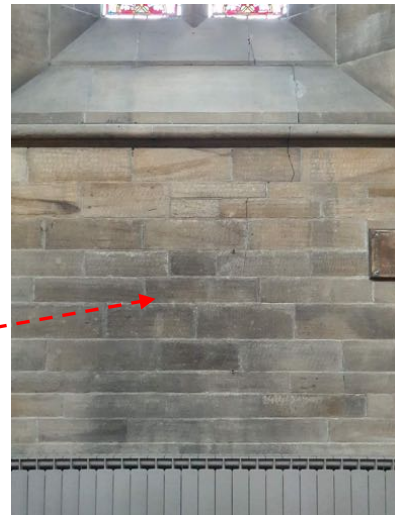
b) Crack below the Nave north window cill

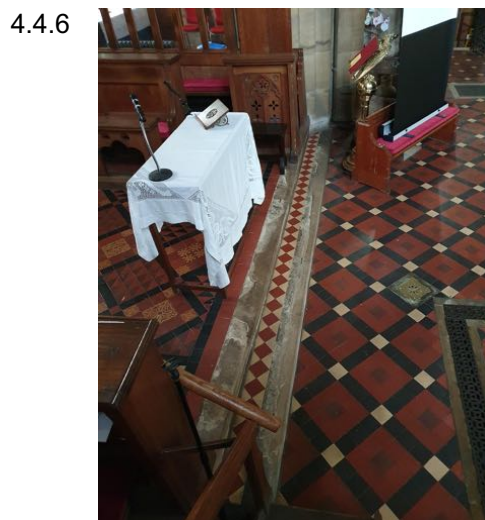
a) Chancel steps shows moisture damage

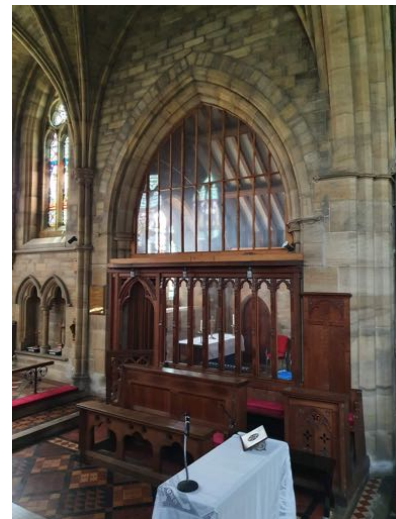
b) Choir stalls and screen separating the Chancel and Chapel

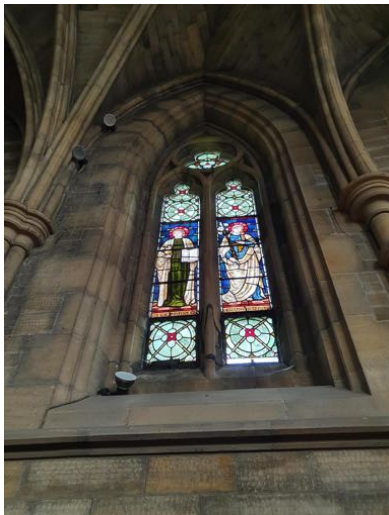
a) North apse window central mullion has been repaired but shows signs of continuing erosion that reflects the location of external masonry defects

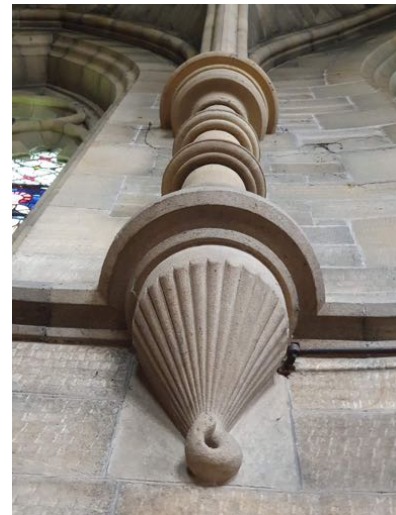
b) Fine carving to pilaster corbels

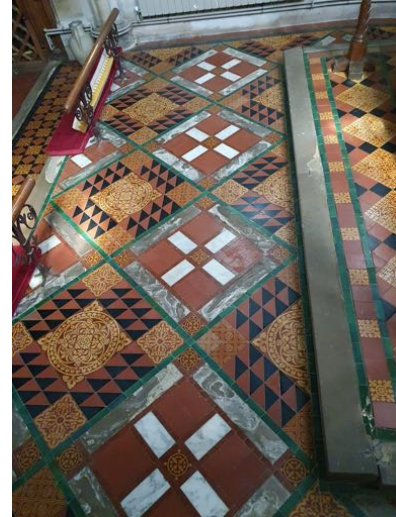
b) Moisture damage is concentrated in the sandstone inserts. The ceramic tiles appear more resilient to rising damp.

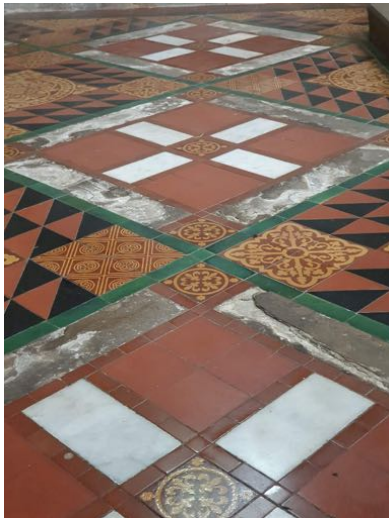
a) Sanctuary floor detail

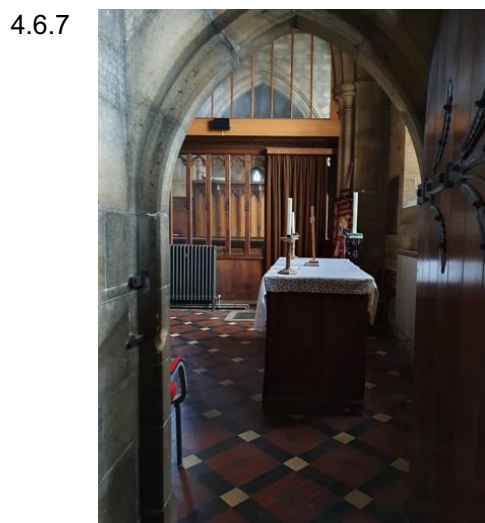
a) View through the doorway from the Vestry

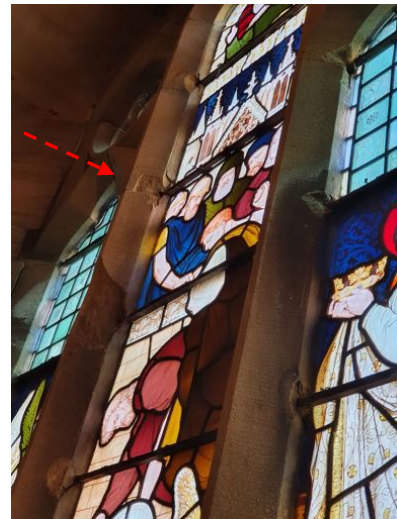
b) Masonry damage most likely due to corrosion in the saddle bars.

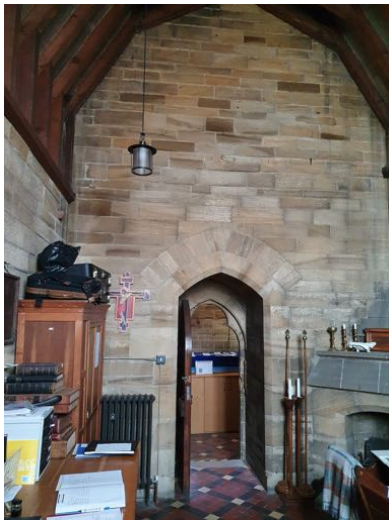
a) Entrance from tower base. Historic staining/ funnel marks at high level. Fireplace in right of photo.

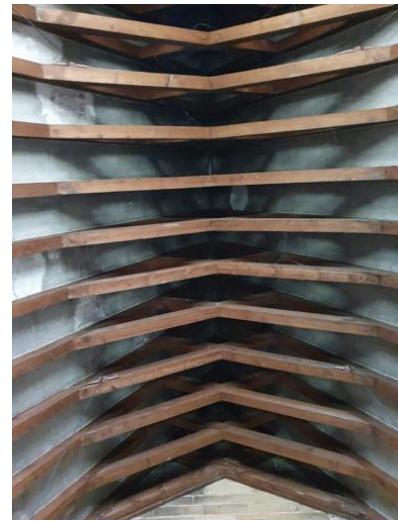
b) Scissor truss roof

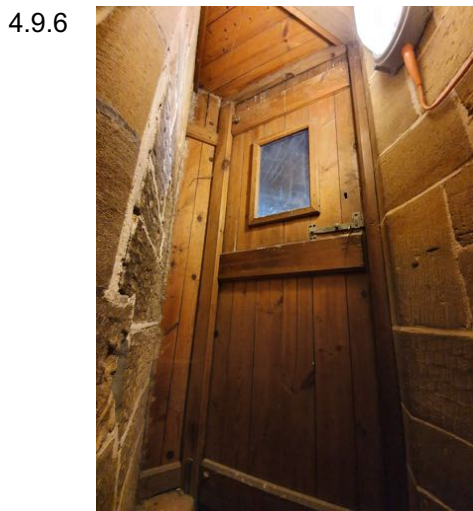
a) Ring chamber door at the top of the stair

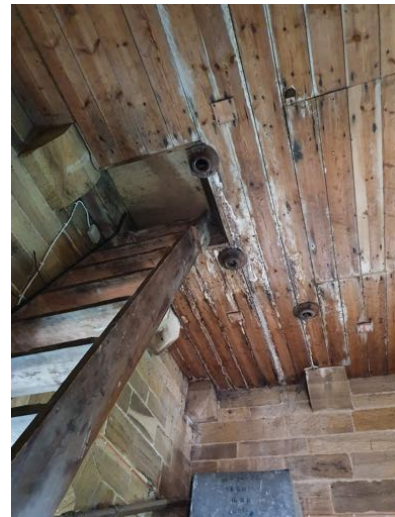
b) Hatch to belfry is awkward to open. Note stained ceiling boards.

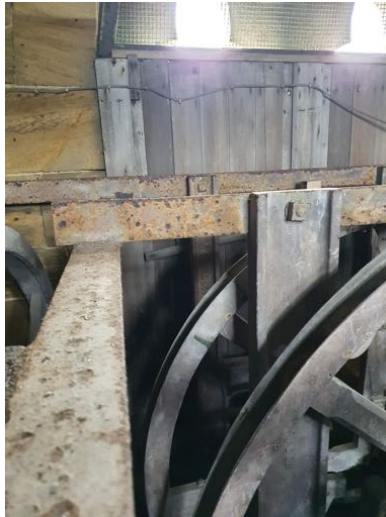
a) Bell frame corrosion

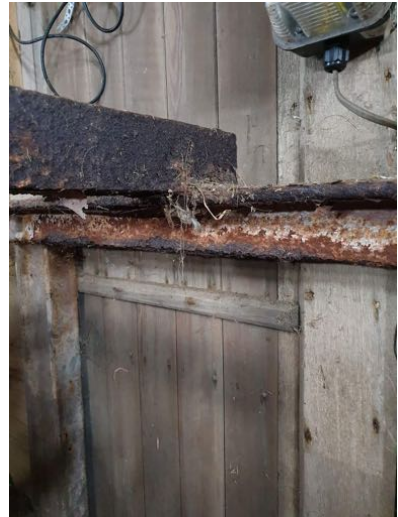
b) Bell frame corrosion

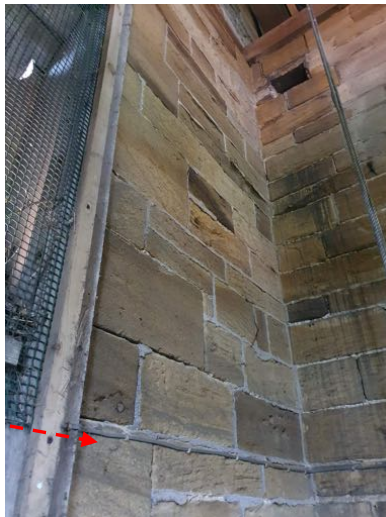
a) Note the light grey cement based mortar

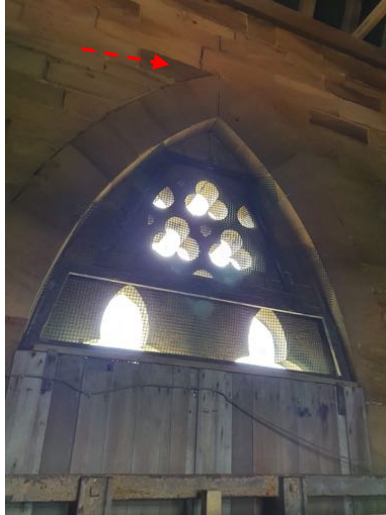
a) Typical Belfry opening. Stepped crack in mortar joint at the head of belfry opening

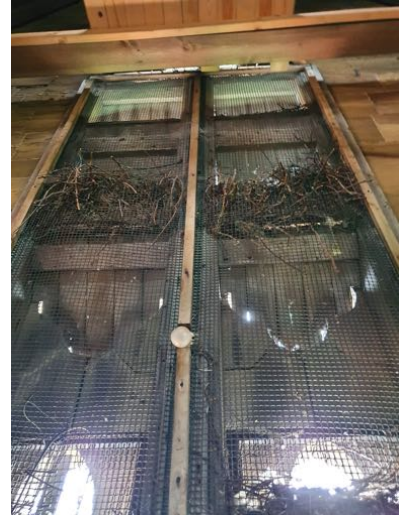
b) Nest established between louvres and mesh.

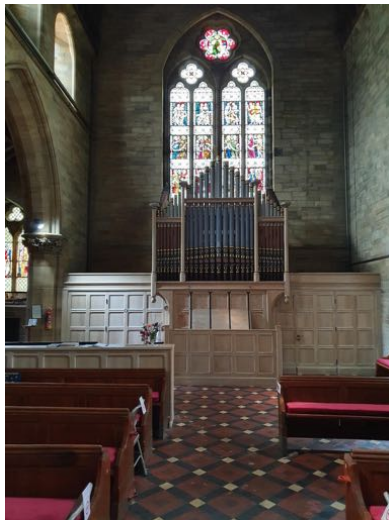
a) Organ with WC and kitchen facilities conceal behind oak panelling at either side.

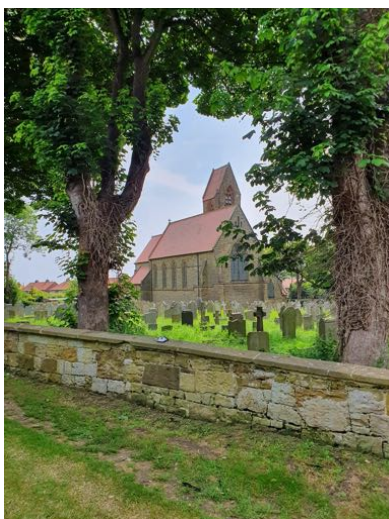
a) North boundary in fair condition

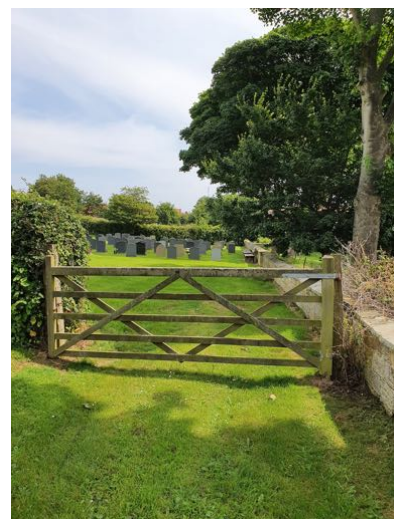
b) North churchyard/ extended burial ground

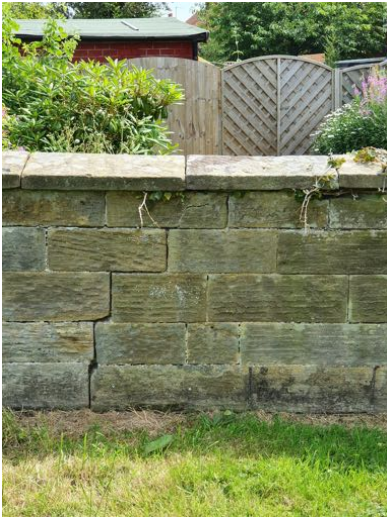
a) Open joints form stepped crack in east boundary wall that ought to be repointed

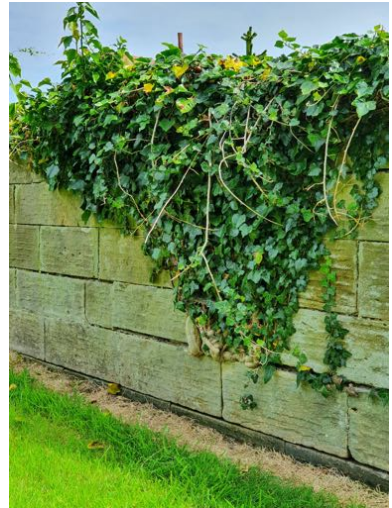
b) East boundary – ivy has grown through the wall and is damaging its construction. The vegetation needs to be cut back, controlled and the wall repaired.
