VENTILATION AND DRAUGHTPROOFING IN HISTORIC CHURCHES

This note was written by Tobit Curteis for the Diocese of Oxford in 2024, and adopted as Church Buildings Council guidance in May 2025.

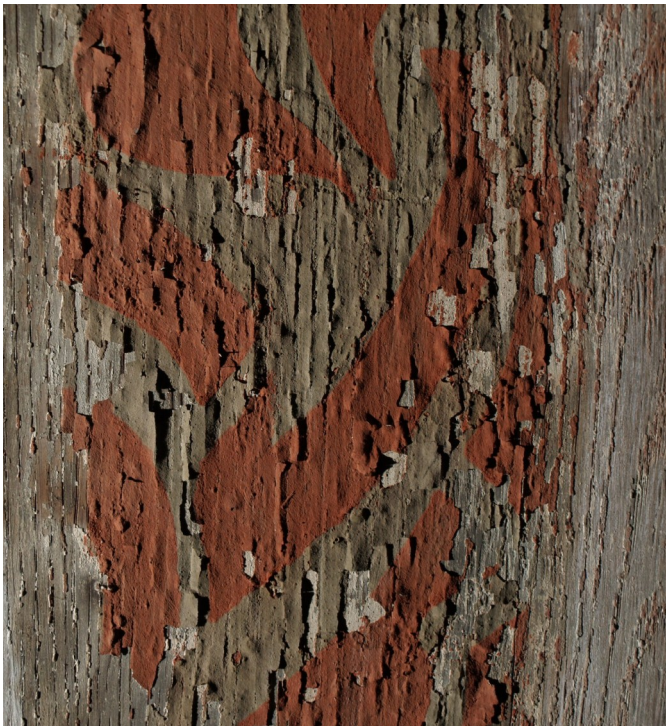
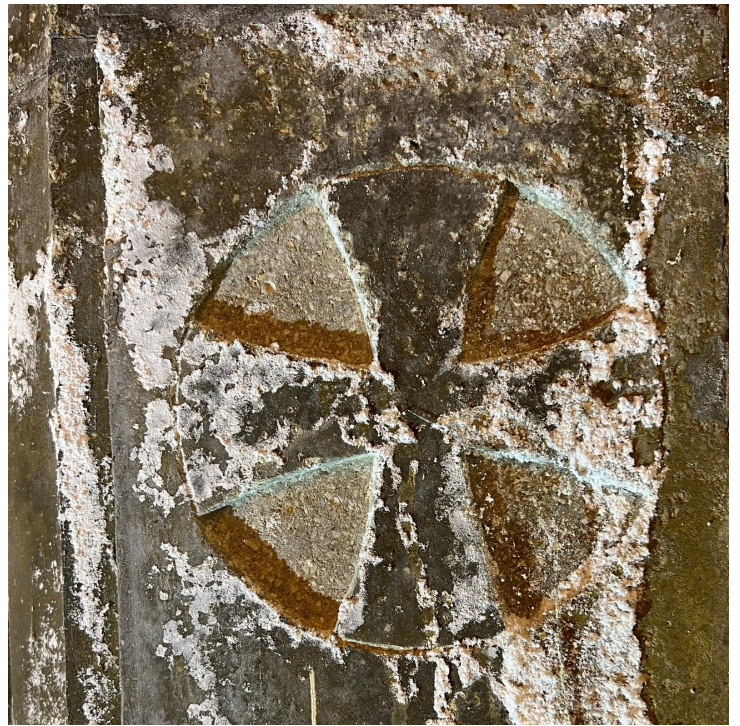
Damage to a painted ceiling and salt deterioration on masonry due to unstable environmental conditions.

In broad terms, effective conservation of the building fabric and the furnishings requires stable environmental conditions without an elevated level of relative humidity (RH). Large fluctuations in RH can cause timber furnishings to expand and contract, sometimes leading to cracking and splitting. If the timber is painted, such as on a ceiling or a rood screen, this can cause flaking and loss of the paint layer. Painted hatchments suffer from the same risks, with expansion and contraction of the canvas causing separation from the paint layers. High RH can also lead to mould growth on textiles, timber and books. On stone and plaster, and on wall paintings, large fluctuations in RH can cause salt activity leading to powdering, flaking and loss.

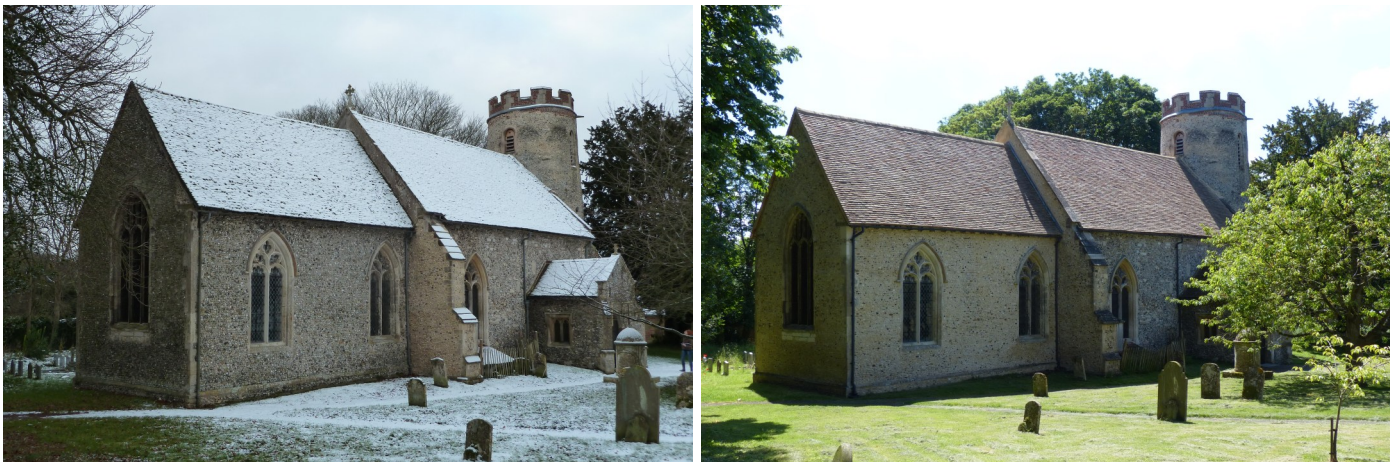
External temperature and humidity are far more unstable than internal conditions.

In a well maintained church, on a typical sunny spring day, the humidity and temperature inside the church is generally relatively stable, varying by less than 10% relative humidity and 2°C, which is beneficial for the conservation of the fabric and monuments. In contrast, external air may fluctuate by more than 50% and 10°C. The introduction of this unstable air into the church will almost inevitably increase the conservation risks to the historic fabric and furnishings (see below).

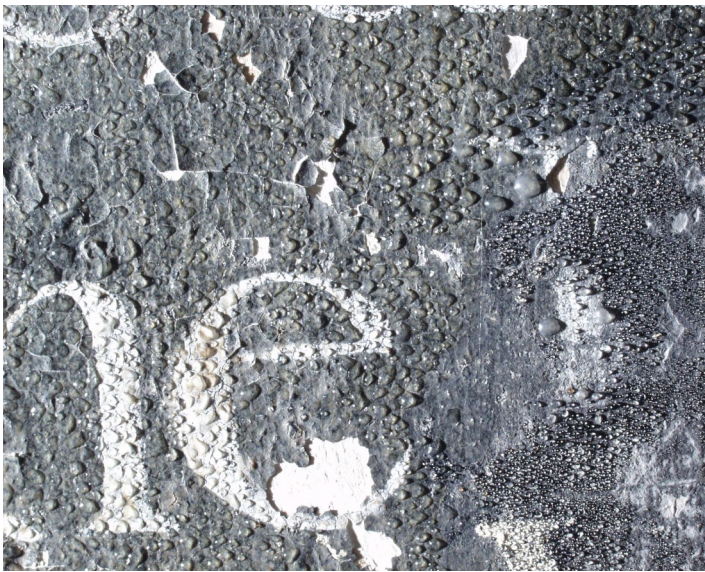
The introduction of warm, moist "fresh" air into a cold church can cause significant condensation and damage.

Due to the potential differences between temperature and humidity conditions inside and outside a church, poorly controlled air exchange can lead to condensation, causing significant damage to the historic fabric and furnishings. This can occur at all times of year, but is most prevalent in the spring when the masonry structure of the church, which is comparatively thermally inert (i.e. it changes temperature slowly), has been chilled over the winter. Outside, as the spring air warms, there is a large increase in the moisture content of the air due to water evaporating from the ground. If windows and doors are opened, sometimes in order to "air the church", the warm, wet external air enters the building in large volumes. This air strikes the cold walls, decreasing in temperature until dew point is reached and condensation forms on the walls leading to the type of deterioration discussed above. Therefore, encouraging ventilation with external "fresh air" in these circumstances can be highly damaging.

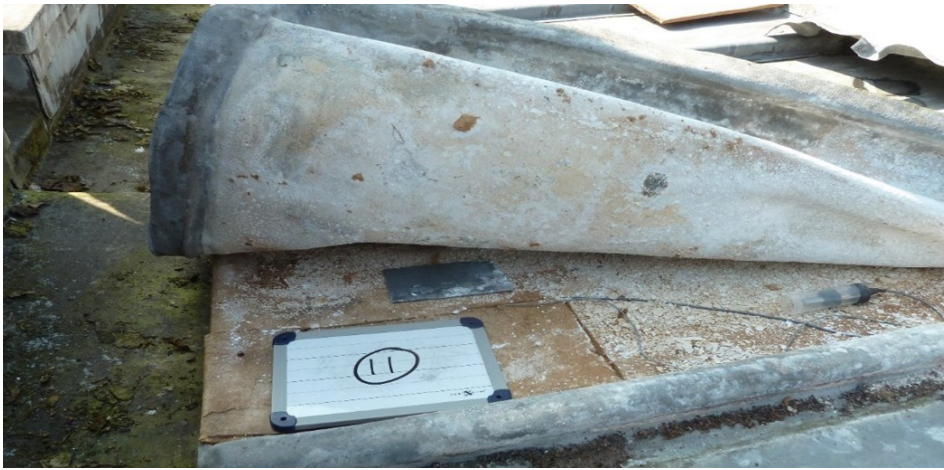
An example of underside lead corrosion: poorly designed roofs with insufficient roof space airflow can lead to severe condensation, resulting in underside lead corrosion.

This is a common occurrence, however, if there is sufficient ventilation around the wet lead, the moisture can evaporate with little damaging effect. In the event of insufficient ventilation resulting from air exchange and movement routes being blocked up, the lead can remain wet, causing underside corrosion and, in the most serious examples, condensation may run onto the adjacent timber, which may then cause dry or wet rot.

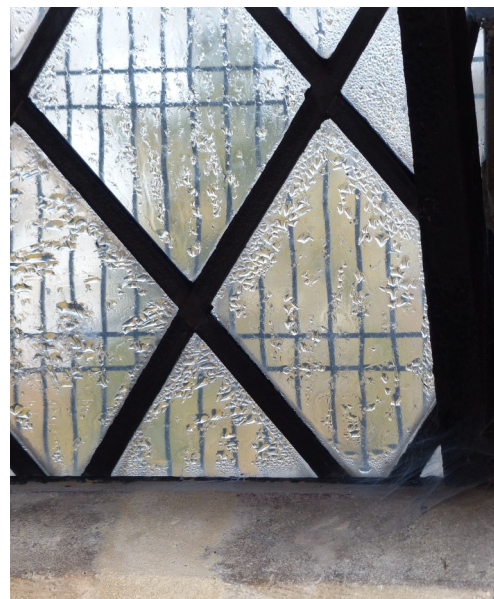
Severe condensation can form on cold surfaces, such as glass, causing damage to adjacent stonework.

In a similar way to condensation issues on roofs, this can also occur on church windows. Glass is generally more robust than lead, however historic stained glass is vulnerable to the effects of condensation, due both to the solubility of the body glass and the possibility of deterioration of the glass paint. The level of vulnerability of different types of stained glass varies depending on how it was made. In contrast to roofs, the surface of church windows are exposed, rather than being hidden behind sarking boards, and air exchange across the surface is generally good, which means that evaporation is easily achieved. Nevertheless, because there can be a significant accumulation of condensation on the relatively impermeable glass, this water can pool and run down the glass, causing damage to the masonry below.

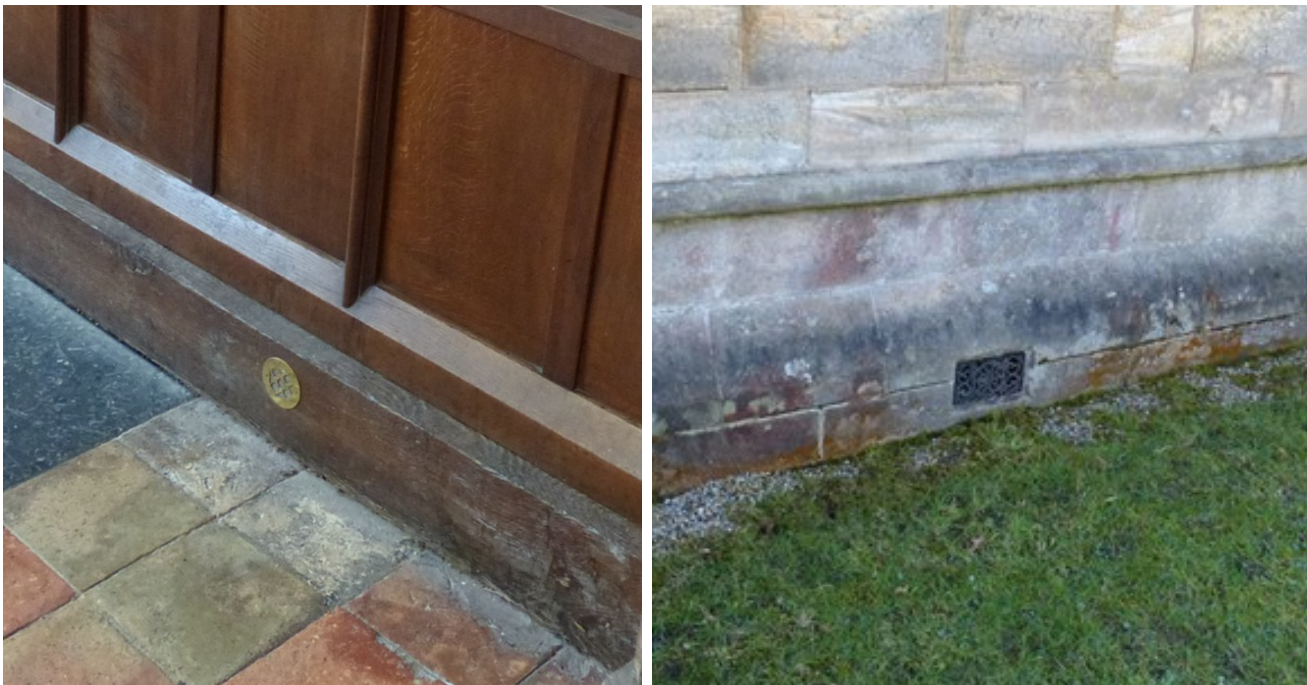
External and internal ventilation openings to under pew voids are designed to reduce moisture levels.

Traditionally, many of these spaces have been intentionally ventilated (external vents to under pew platforms and ventilation openings into wainscoting). However, many of these openings have been closed up either due to a misunderstanding of what they were for, or so as to prevent uncomfortable draughts.

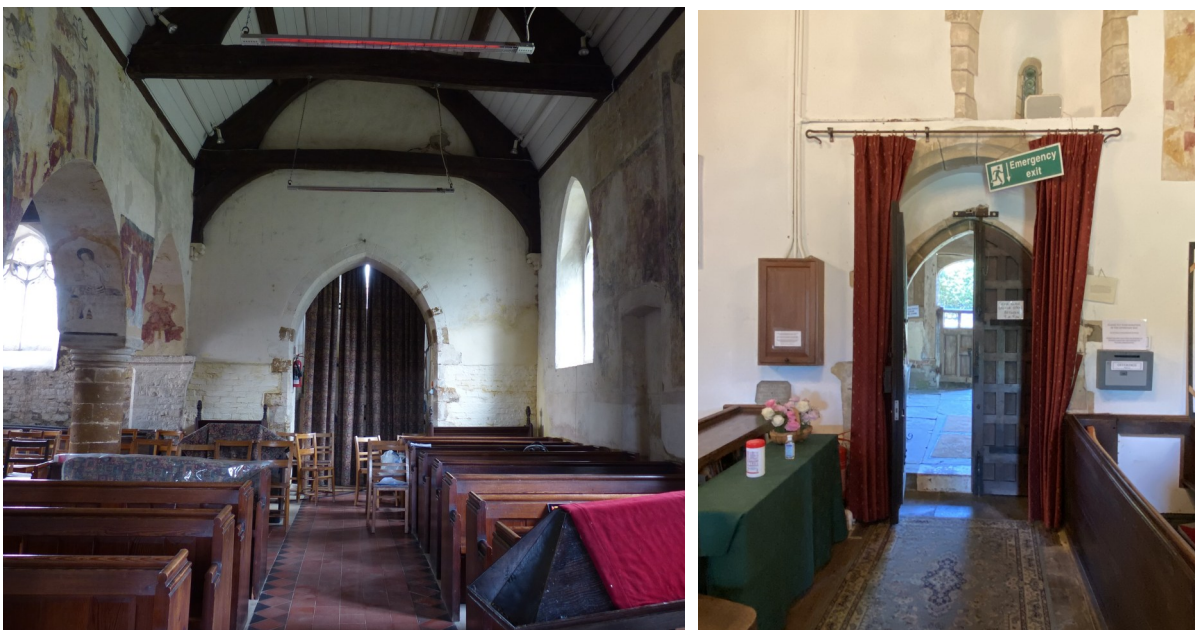
Tower curtains and external door curtains can significantly reduce air movement and draughts.

In the 19th century, a church would often have door curtains to block draughts, box pews, often upholstered, to create cosy, draught free spaces, and pew cushions and mats to reduce heat loss to the cold structure, thereby providing greater overall comfort. During the 20th century, as fashions changed, many of these features were removed from churches, making the building more vulnerable to draughts and sources of uncomfortable cold.
